Aviation Investigation Preliminary Report

Location: Jersey City, NJ Accident Number: ERA25MA171

Date & Time: April 10, 2025, 15:15 Local Registration: N216MH

Aircraft: Bell 206L-4 Injuries: 6 Fatal

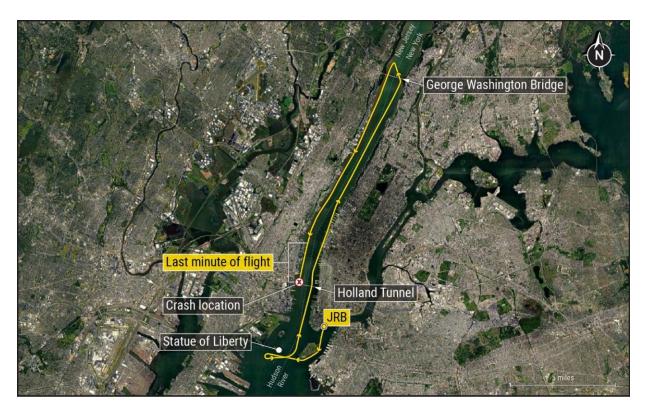
Preliminary Automatic Dependent Surveillance-Broadcast (ADS-B) flight track data obtained from the Federal Aviation Administration (FAA) revealed the helicopter departed Downtown Manhattan/Wall Street Heliport (JRB), New York, New York, about 1458. The helicopter flew a teardrop pattern south of the Statue of Liberty, then proceeded north along the east side of the Hudson River adjacent to Manhattan, past the George Washington Bridge, where it performed a u-turn, then headed south along the New Jersey side of the river (figure. 1).

Figure 1. ADS-B flight track overview of entire route of flight from takeoff through loss of signal near the accident location.

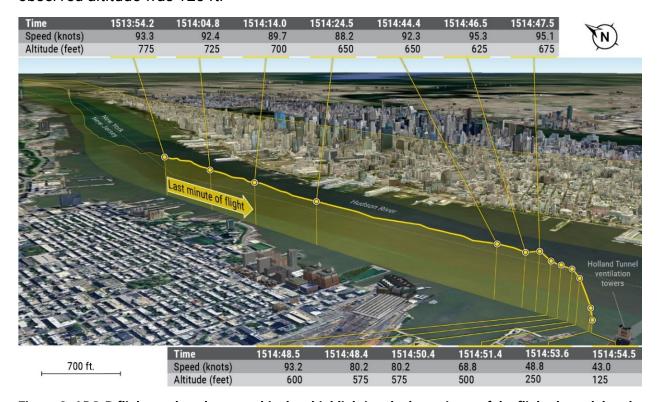
Figure 2 depicts the plot of the helicopter's ADS-B-observed flight path for the final 1 minute of flight, with the reported time, altitude and groundspeed superimposed. As the helicopter approached the Holland Tunnel ventilation towers near Jersey City, New Jersey, it was at a geometric altitude between 625 and 650 ft. The helicopter's altitude increased to 675 ft msl

before it entered a rapid descent. The data ended at 1514:54.5 and the helicopter's last observed altitude was 125 ft.

Figure 2. ADS-B flight track and geographic data highlighting the last minute of the flight through breakup, uncontrolled decent and loss of signal.

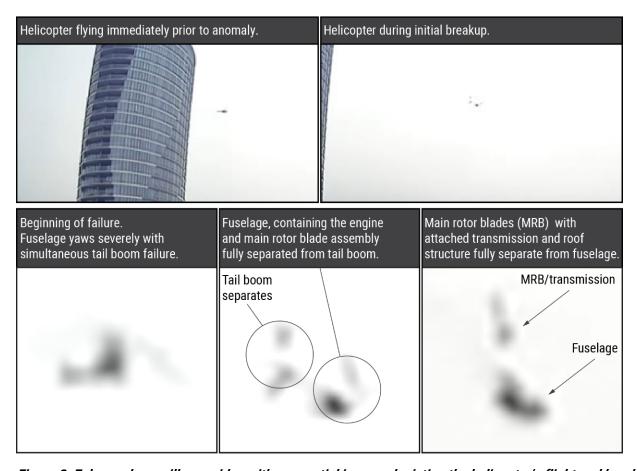
Several witnesses described hearing several loud "bangs" emanating from the helicopter before it broke up and descended into the river. Surveillance video (with accompanying audio) captured the helicopter traveling south before it suddenly separated into three major sections: fuselage (including the engine), main rotor system (including both main rotor blades, transmission and roof-beam structure), and the tail boom (including the tail rotor) (figure 3).

Figure 3. Enhanced surveillance video with sequential images depicting the helicopter's flight and breakup.
